# REHABILITATING STREETS AND BUILDINGS IN NASHUA

A GUIDE FOR  
FACADES,  
STREETS AND  
MORE

CITY OF NASHUA, NH

DOWNTOWN NASHUA

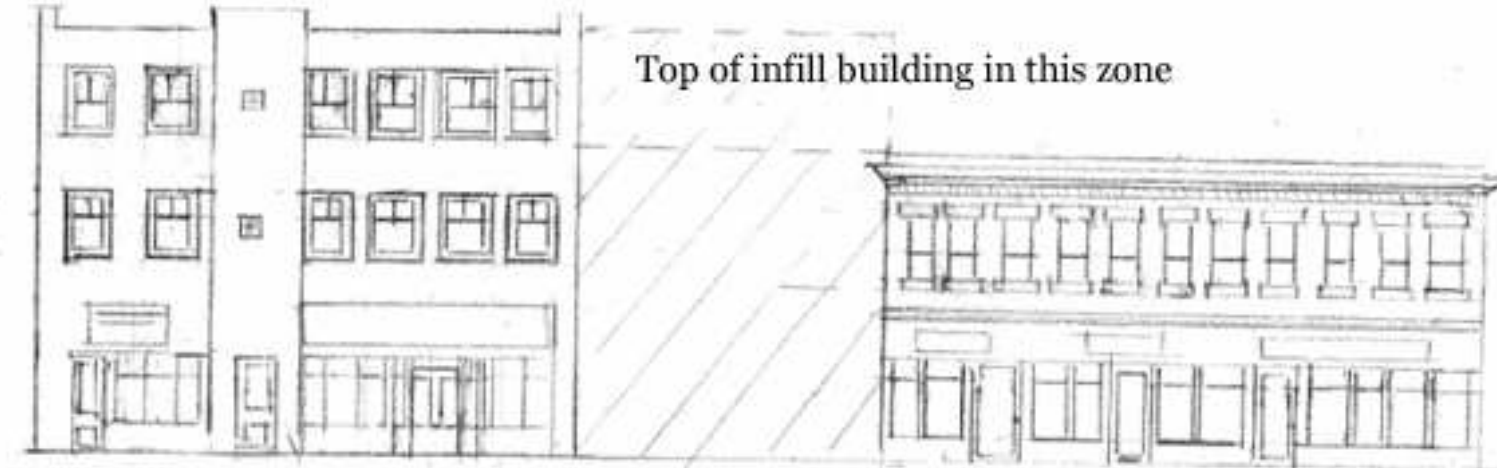
When adding infill buildings, they should remain true to the character of the block.

Infill buildings shall maintain a common setback and be of similar height and width to adjacent homes. Roofs and the building itself should be consistent with abutting properties.

Commercial infill buildings should be flush with other buildings and up at the sidewalk.

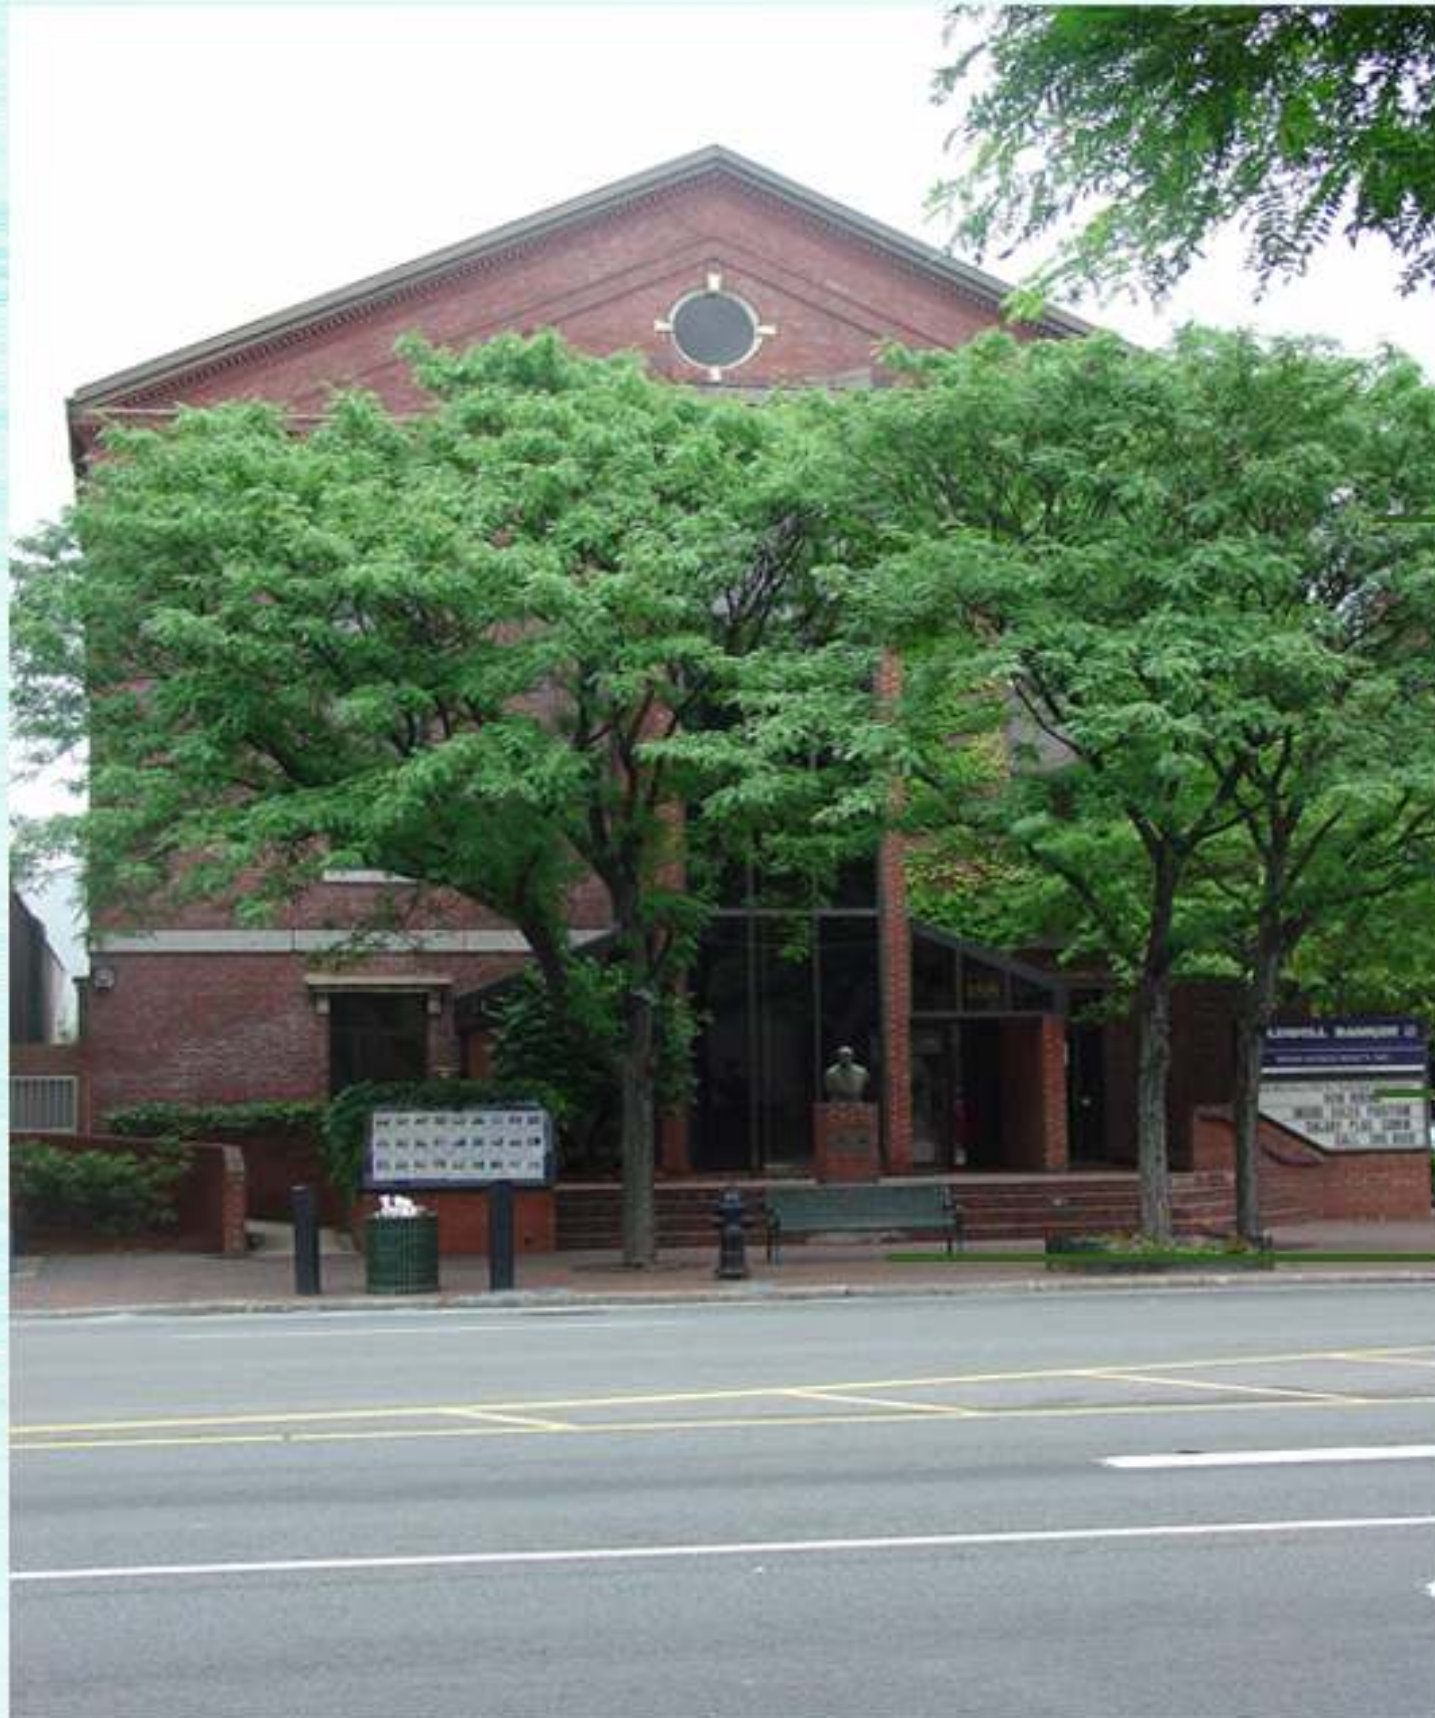
## 188 Main Street

The building at 188 Main Street maintains many of its original features. Appropriate signage and landscaping will serve to enhance the facade.

Cut one of the three trees and trim the existing trees to reveal the front of the building

Remove some of the ivy to reveal architecture detailing

Replace internally lit box signs

Relandscape the area near the building

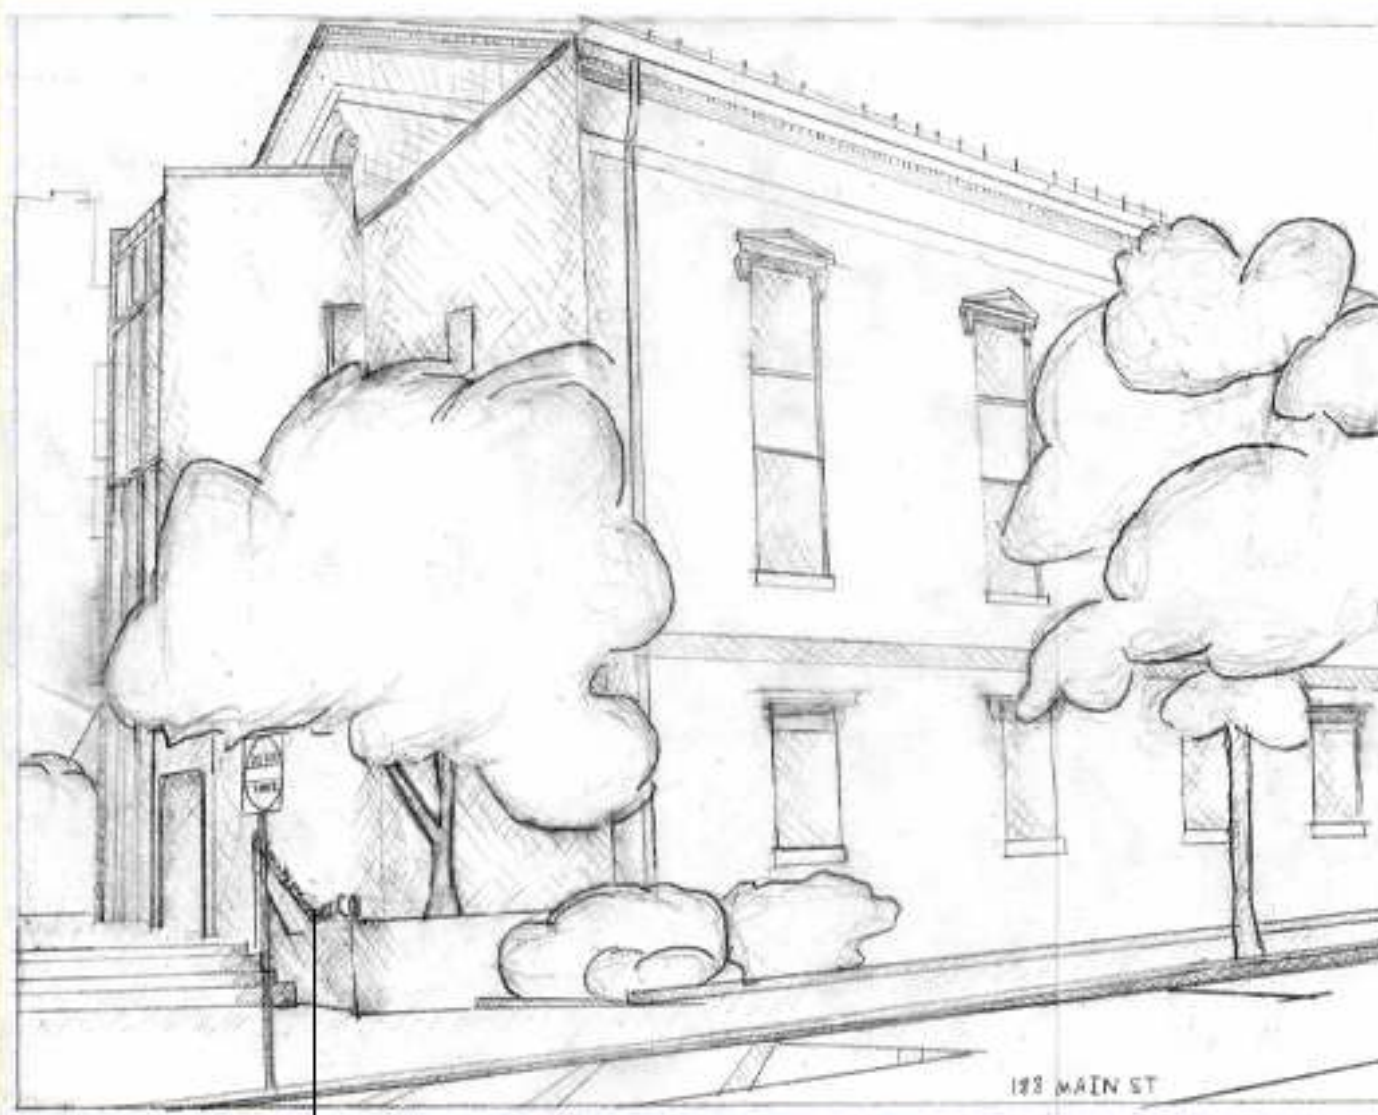
Signage

By adopting this type of signage, similar to this example from Boston, 188 Main Street can still have illuminated signage. It also is more enticing to the general public than the internally lit box signs.

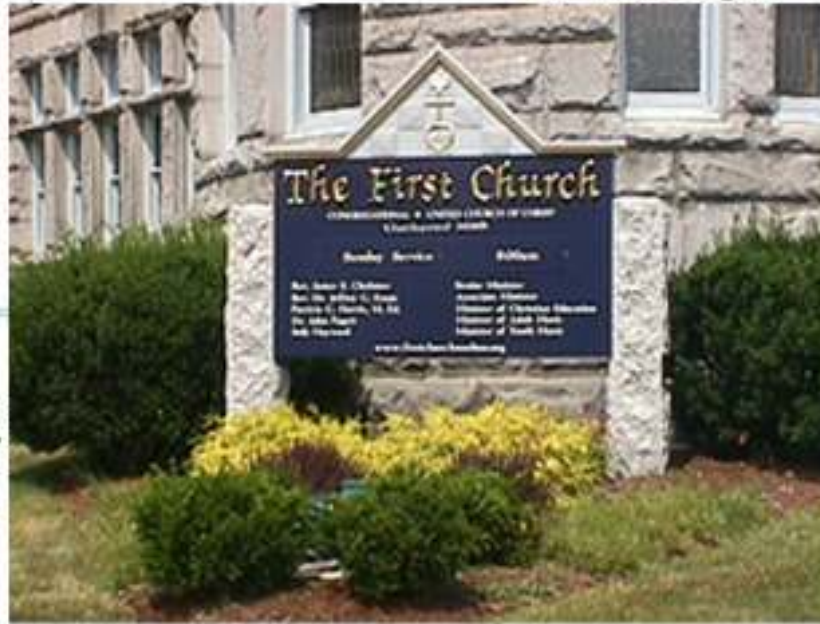
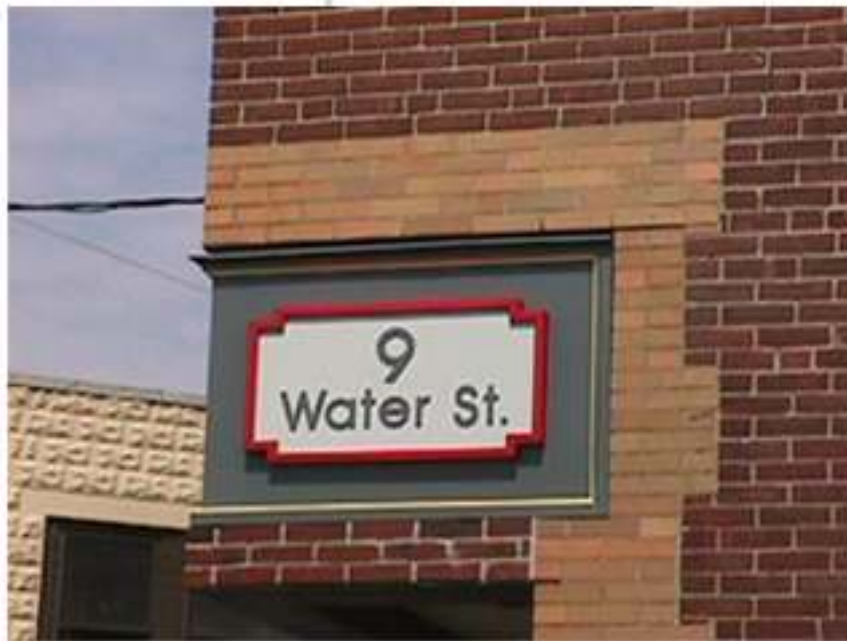
## Ground Signs

Maintaining proportions of the sign in relation to the building is crucial.

Free standing signs should be made of wood on steel poles.

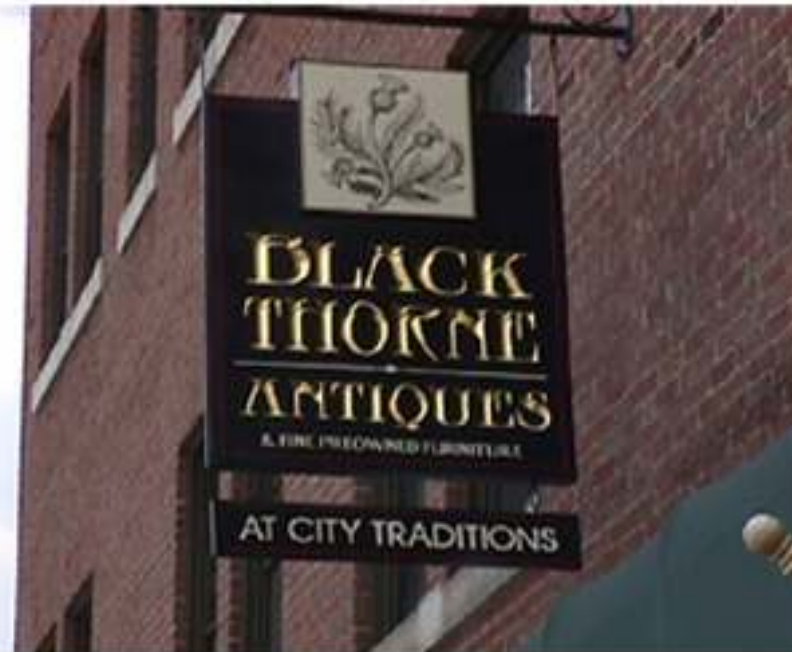
## Wall Signs

Business signs should not obstruct other buildings, other signs, or important views.

Wall signs should stay within the entablature for a building. The lettering and logos should fit with the character of the building.

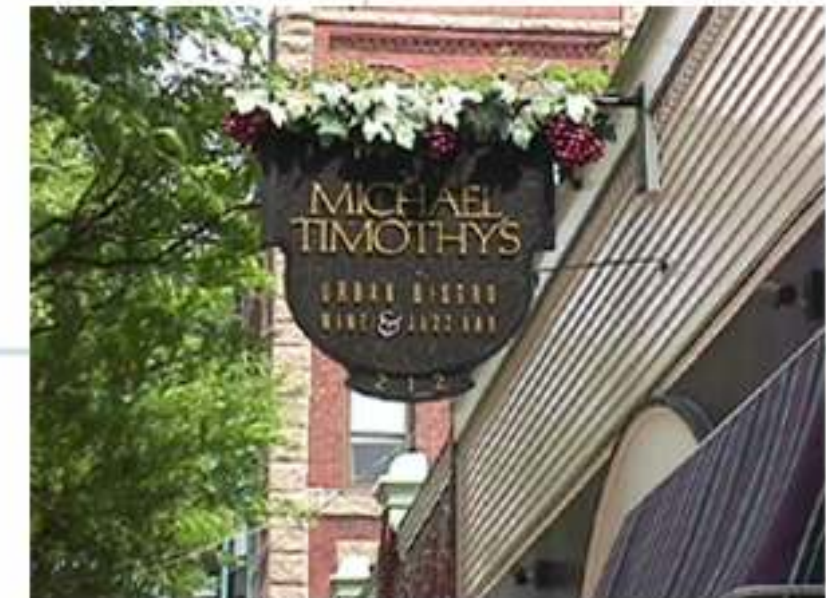
## Projecting Signs

Wood should be used for projecting signs with paint, the text and/or emblems.

Signs should be easily readable and the color scheme should correspond with the building and surrounding area. Using bright colors that do not fit with the historical character of a building are inappropriate.

Signs should complement the architecture, particularly on historic buildings.

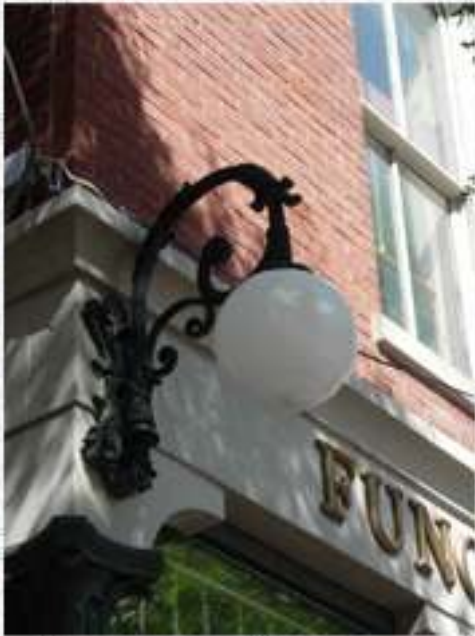
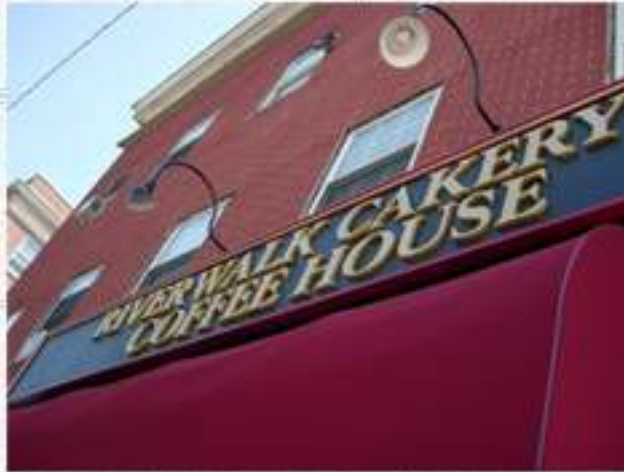
# Lighting

Internally illuminated box signs are discouraged.

Externally illuminated signs are strongly encouraged.

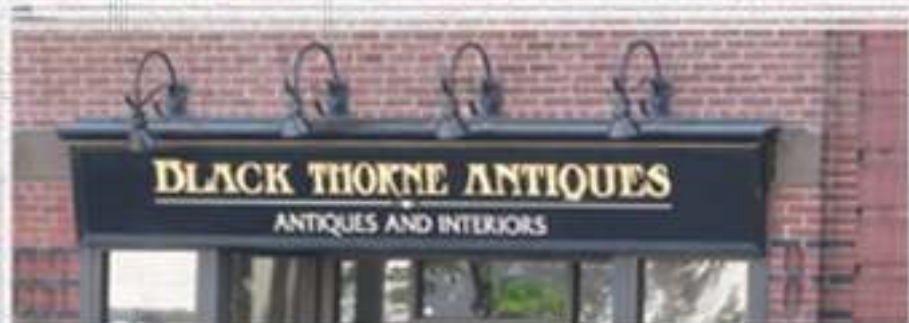
Light fixtures that are cantilevered at a consistent distance for the building are especially appropriate in downtown.

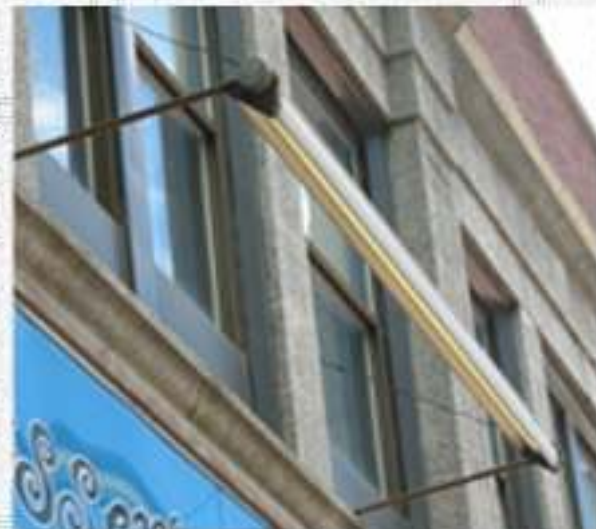
Examples showing the numerous possibilities for Downtown.

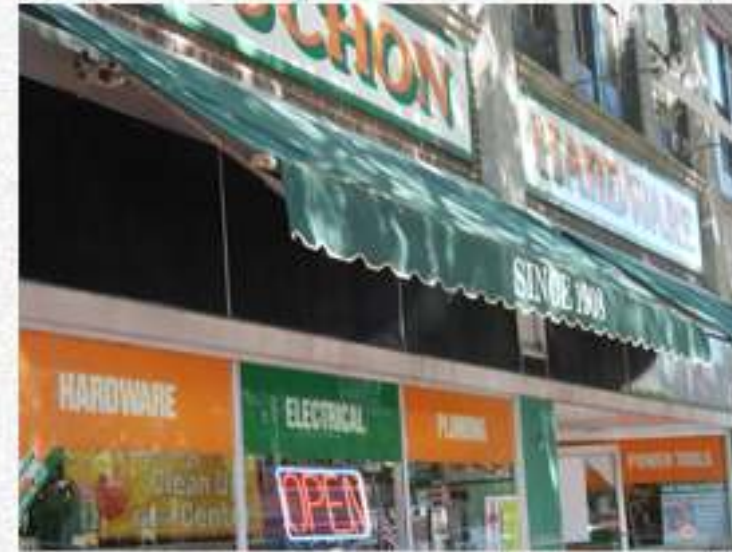
Awnings should be of canvas material. The use of aluminum or rigid plastic awnings is discouraged. Supports should be non-corroding, with such materials as galvanized or stainless steel.

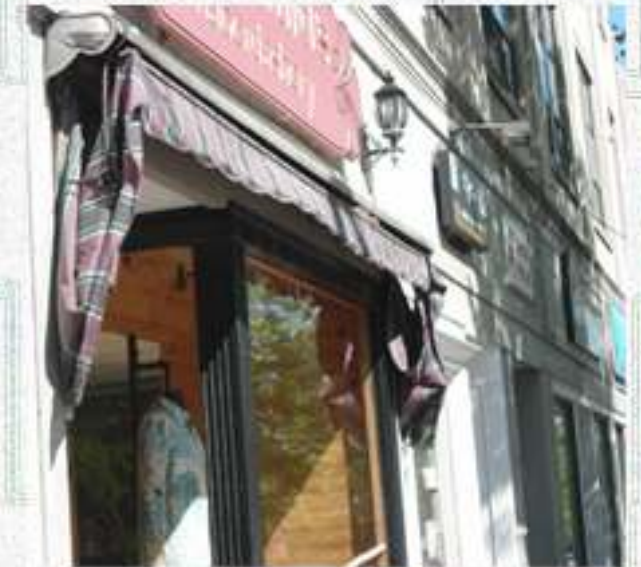
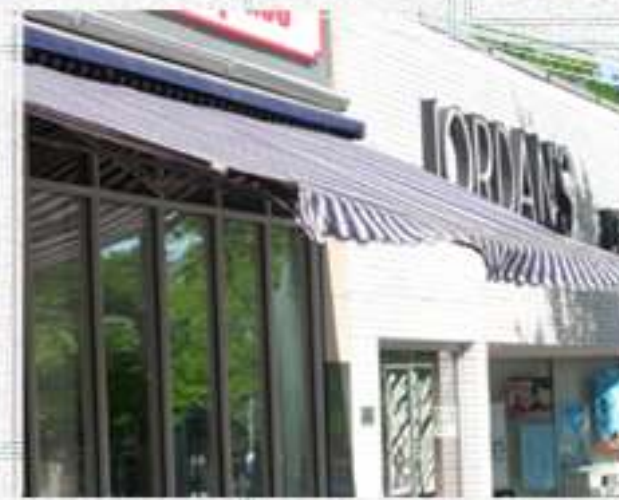
# Awnings

Canvas material has an average life expectancy of 4 to 7 years and awning coverings should be replaced after this amount of time.
